**LABOND “MPSeal I301pu” – Pipe Through Wall Problem**  
**立康牌 “MPSeal I301pu” 液態聚安脂防水注射系統 - 過牆喉問題**

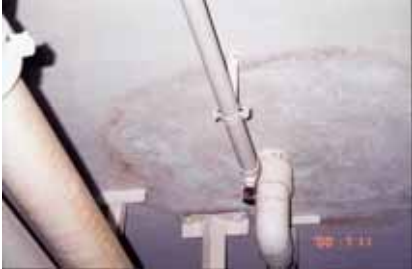
| <p><b>Step 1 步驟 1</b><br/>Observe the area of water sweepe, then find out the source and reason of problem.<br/>先觀察漏水位置，了解滲水原因及位置。</p> | <p><b>Step 2 步驟 2</b><br/>Make sure necessary tools including MP A360 high pressure hand pump, MPSeal I301pu, Mp nozzle A903, 1 drum of clean water, 1 drum of xylene are ready.<br/>先準備好萬寶 A918 高壓泵, A903 針咀, Mpseal I301pu, 一桶清水, 一罐天拿水。</p> | <p><b>Step 3 步驟 3</b><br/>Set up “injection holes” for every 150 to 200 mm leaner distance ( with 45° across the surface along the water sweepe area) by drilling machine for embedding injection nozzle.<br/>沿漏水範圍，每隔 150mm- 200mm 以 45° 斜度鑽開可轉入打針咀的洞口。</p> |
| | <p align="center"><b>技術意見</b></p> <p>以上範例只是其中一種漏水情況，形成原因是安裝每層之間的過牆喉時，填封水泥不當，水泥層出現不規則滲水，打針範圍是沿水影分散種針。</p> | <p align="center"><b>Technical Data</b></p> <p>The above desmountration in just one of the water sweeper problem caused by in proper installation of pipe through wall between “Floor to Floor” The path of water sweeper is irregular, therefore injection nozzle are set around the water sweeper area.</p> |

| <p><b>步驟 4</b><br/>Install Mpnozzle A903 and twist tightly by tool.<br/>放上針咀並以“士巴拿”以扭力逼緊針咀。</p> | <p><b>Step 5 步驟 5</b><br/>Firstly starting injection of clear water into the hole by MP A918.<br/>開始用“MP A918”壓力泵注入清水。</p> | <p><b>步驟 6</b><br/>During “water injection” is undergoing, pressurized water will flow along the truck crack and then path into it’s potential subsidiary cracks ; water will finally sweep from those cracks. Then, shift to another hole with same procedure.<br/>每次注水時，水份會從主幹裂痕分流至其連接的支流裂縫位置。水份會從裂縫滲出。完成後，轉移到另外一個針孔。</p> |
| <p><b>步驟 7</b><br/>After completion of “Water injection” for all setted nozzle, clean the tools (pump, host) by xylene solvent to ensure that there is no water portion in the tools. Then start “Mpseal I301pu injection” by same tools and same method as step 6.<br/>在所有位置完成灌水後，先將工具（針，喉及泵）用“天拿水”洗好，不能有水份接觸，然後依照步驟 6 注射針水。</p> | <p><b>步驟 8</b><br/>During injection of “MPSeal I301pu”, water will sweep from the cracks, then follow by “white colour jelly liquid”. (This indicate that MPSeal I301pu just partially react with water). If this kind of jelly liquid keep running out, that means the flowing rate of injection is too fast to allow completed reaction between MPSeal I301pu and water. In this case, stop pumping action and seal the hole by “waterplug” mortar. Restart the injection process afterward. For successful injection, the sequence of material flowing out from the hole are “Water”, “White-Jelly liquid”, “Yellow foamy liquid”. Then, sweeping problem should stop immediately. But in some case, sweeping problem might start again after a few days, start injection procedure again until all potential water sweeping path are sealed by MPSeal I301pu.<br/>常灌入針水後，水先會從裂縫流出，再出現白色厘狀（這顯示 MPSeal I301 只局部性與水份產作用），如果此類持續流出一段時間，這是因為注射縫度太快，MPSeal I301 未有足夠時間與水完全產作用。這情況下，需先停止注射，用快乾英泥封妥出口，待針水凝固好，再補針。如屬成功注射，從裂縫流出液體次序為水，白色液體，最後是黃色針水。然後所有滲漏情況便即時停止。在一些情況下，有可能隔數天後會再漏，只需再補針注射張剩餘漏水位置封妥便可。若針水滲出的情況非常嚴重則代表針水未趕及潮脹已被割出，在這情況下，需用快乾英泥暫時封好，待針水凝固，再補灌。如想取得更好效果。一般情況下，處於漏水狀態的裂縫或蜂巢石尿會在打針後，立即達到止水效果。若是仍然有水流出，則需繼續加孔補針直至止水為止。</p> | |
